Old St. Anastasia Catholic School - EXTERIOR REPAIRS & ROOF REPLACEMENT

910 Orange Avenue, Fort Pierce, Florida 34950

EXTERIOR REPAIRS

COVER

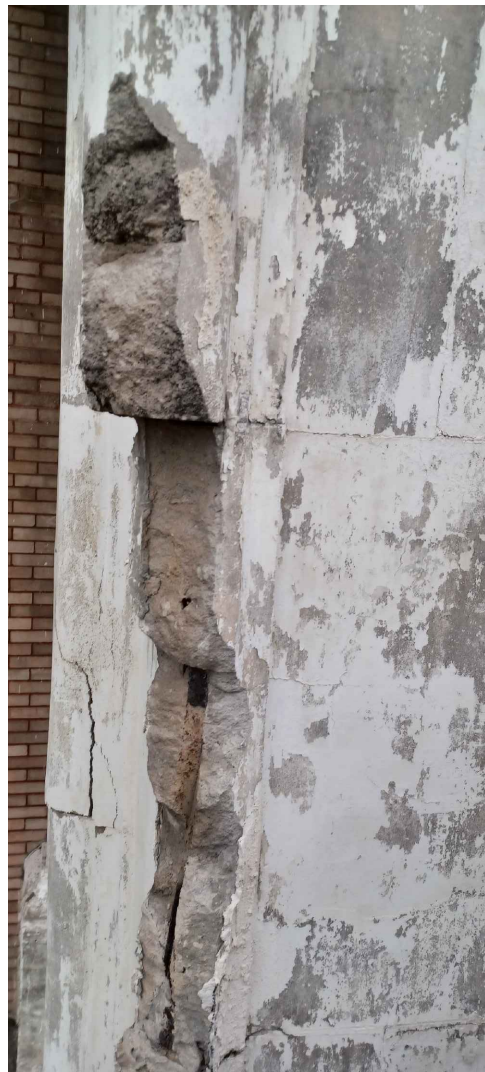
1 | PORTICO COLUMN.

Deterioration at portico column. Remove deteriorated concrete and patch. Coat. See specifications.

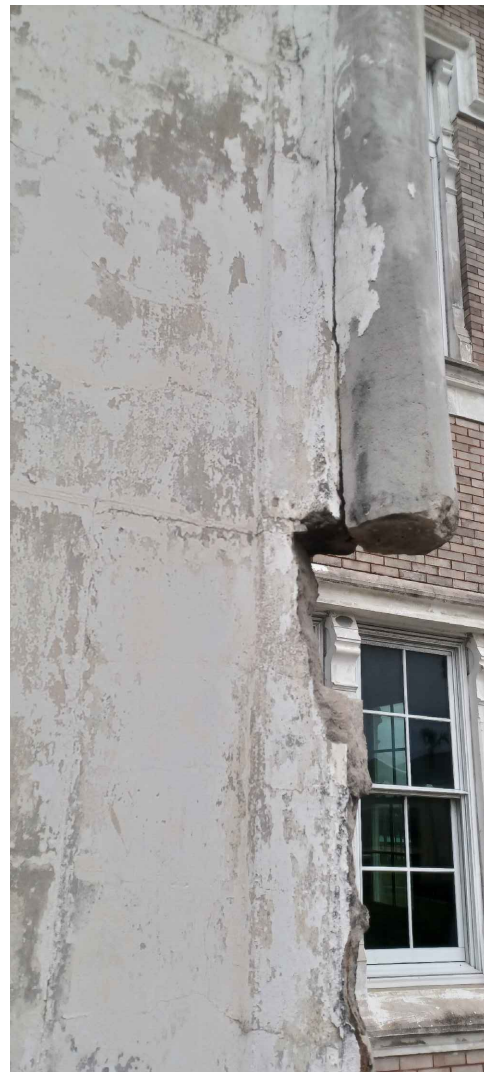
2 | PORTICO COLUMN.

Deterioration at portico column. Remove deteriorated concrete and patch. Coat. See specifications.

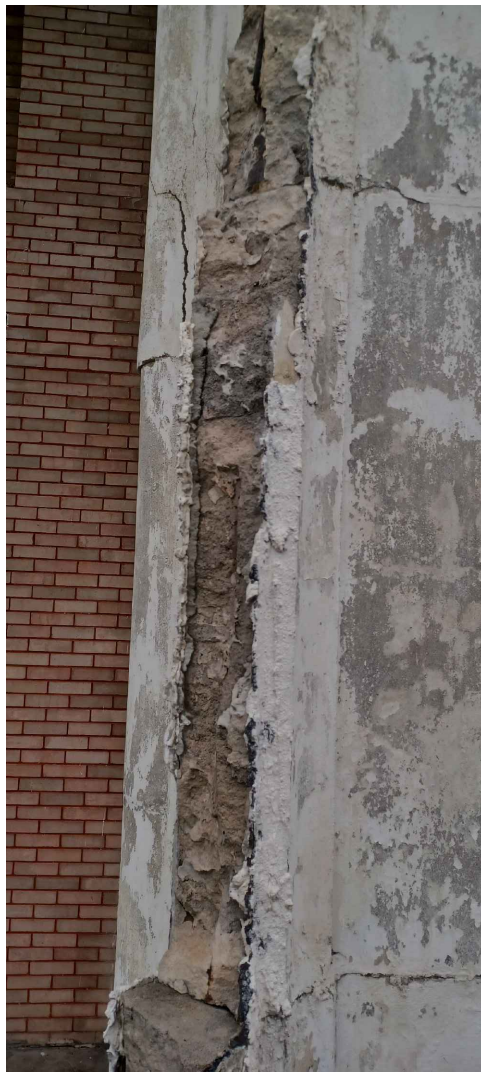
3 | PORTICO COLUMN.

Deterioration at portico column. Remove deteriorated concrete and patch. Coat. See specifications.

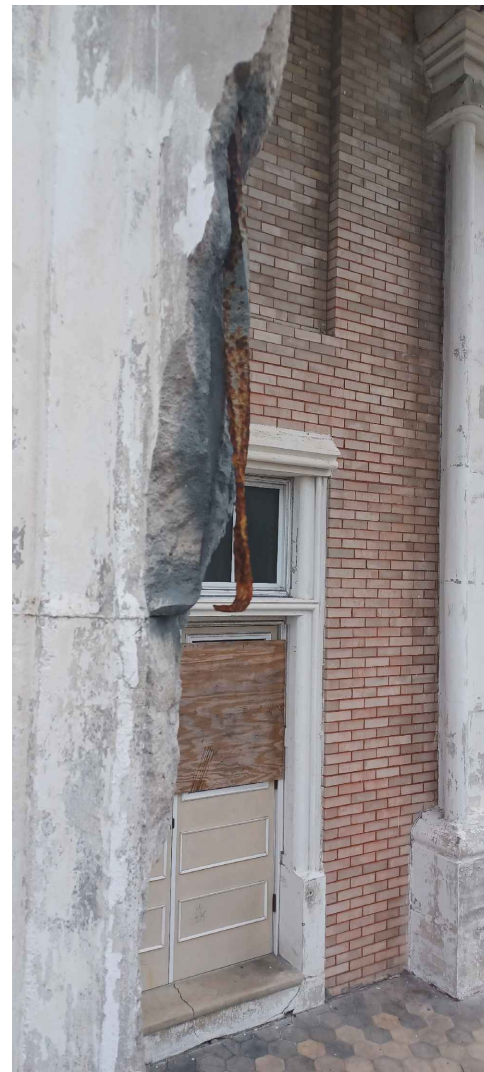
4 | PORTICO COLUMN.

Deterioration at portico column. Remove deteriorated concrete to expose sound reinforcing. Replace deteriorated reinforcing and patch concrete. Coat. See specifications

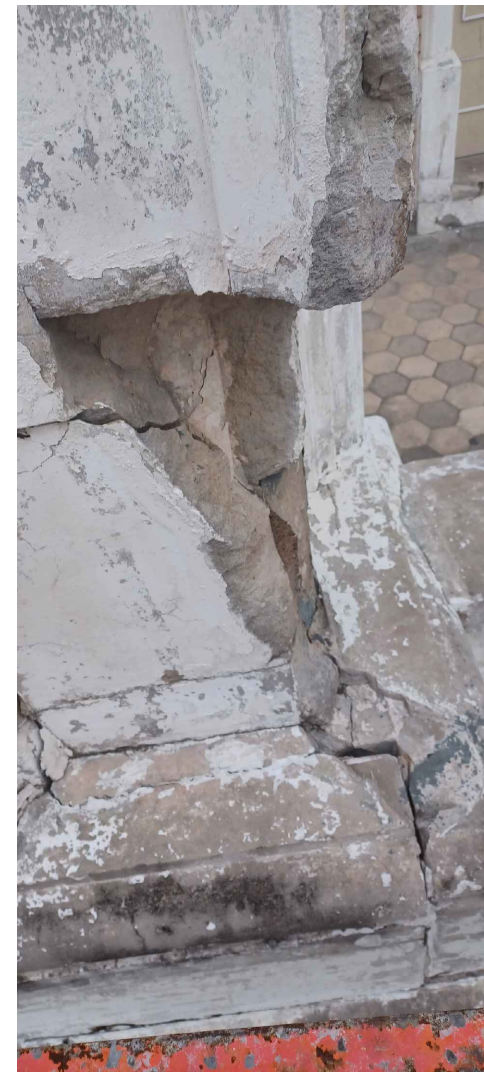
5 | PORTICO COLUMN.

Deterioration at portico column. Remove deteriorated concrete and patch. Coat. See specifications.

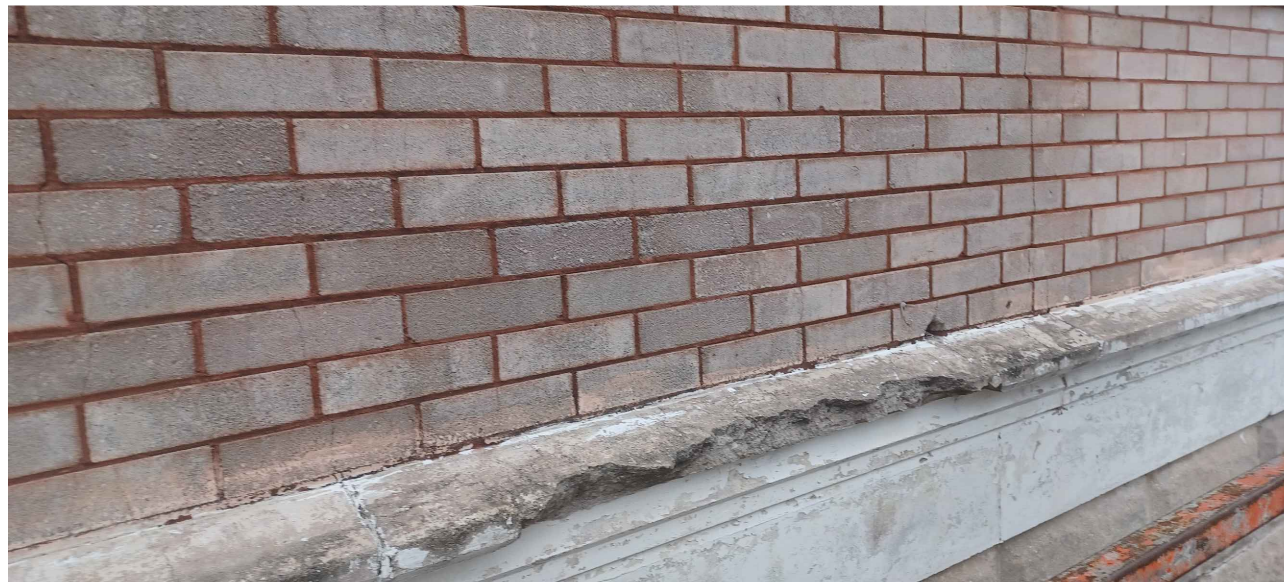
1 | BELT COURSE

Deterioration at belt course. Remove deteriorated material and patch. Coat. See specifications

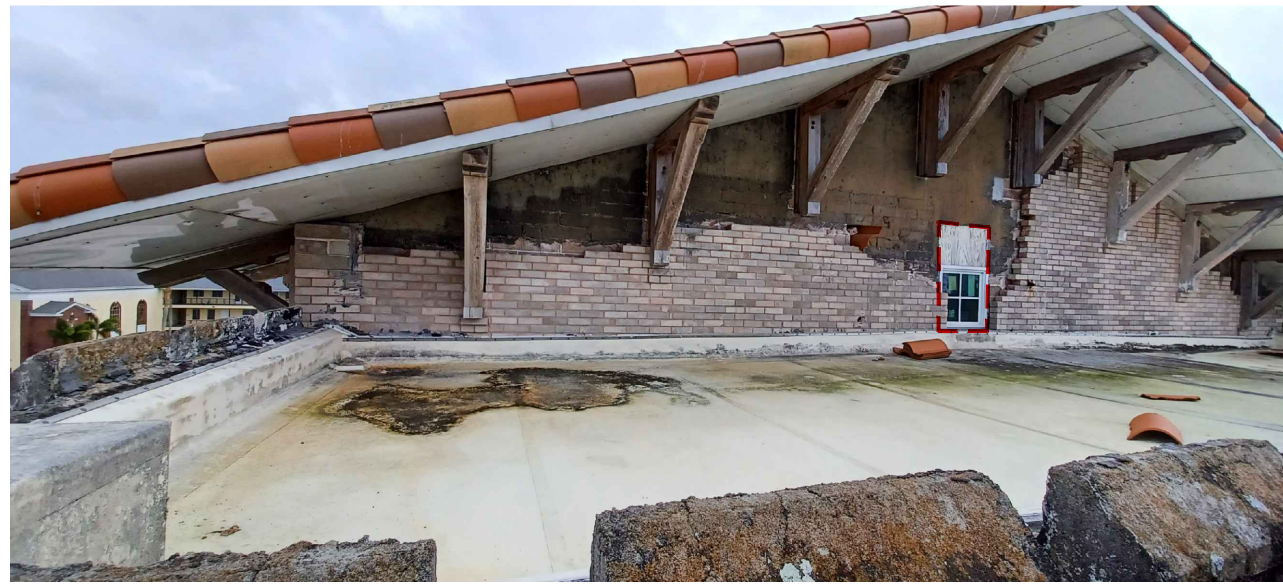
2 | NORTH WALL

Area of missing brick at north wall of main block of building. Remove all brick. Install new brick selected by architect.

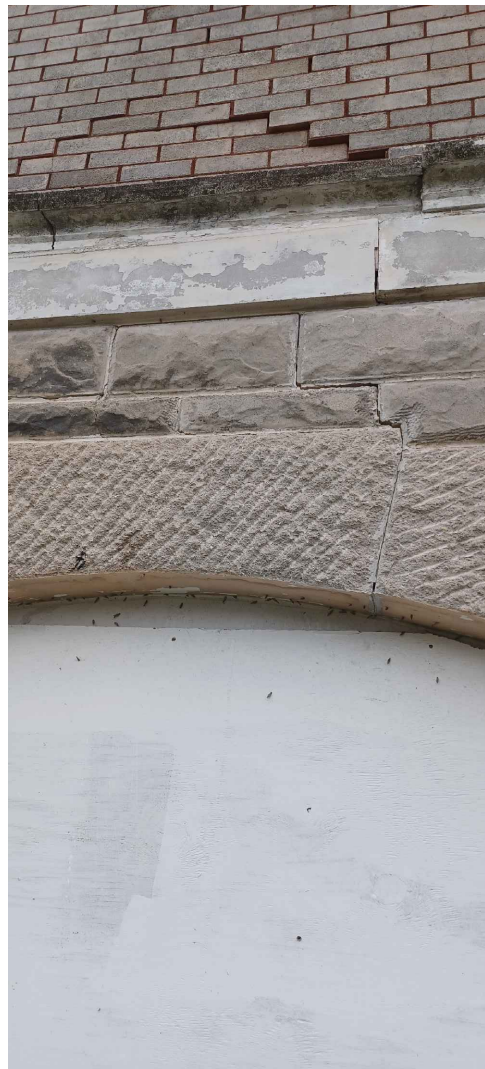
3 | DISPLACED BRICKS

Area of displaced bricks. Remove approximately 30 bricks to allow inspection. Rebuild to even plane.

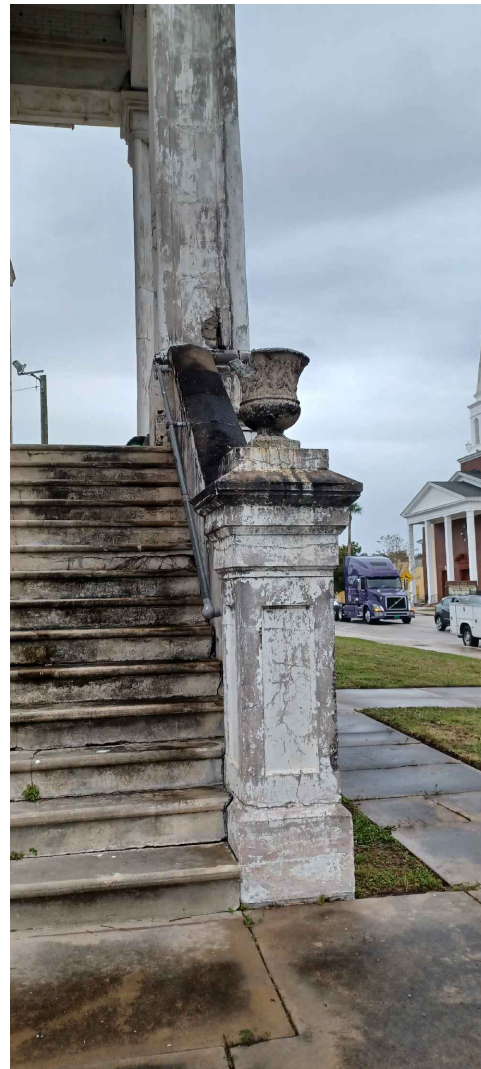
4 | PORTICO

Deterioration at portico column and balustrade. Re-anchor urn. Remove deteriorated concrete and patch. Coat. See specifications.
